PROPERTY RESTORATION

Case Study: NEW LONDON PUBLIC SCHOOLS
Nathan Hale Arts Magnet School
New London, CT

Loss Event: Water Damage

Damage: Extensive water damage in classrooms and hallways.

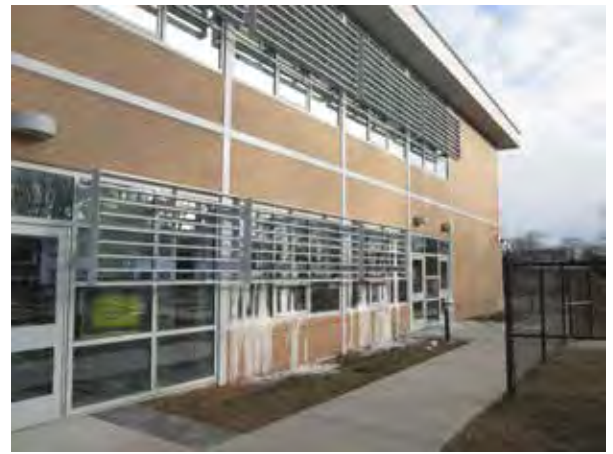
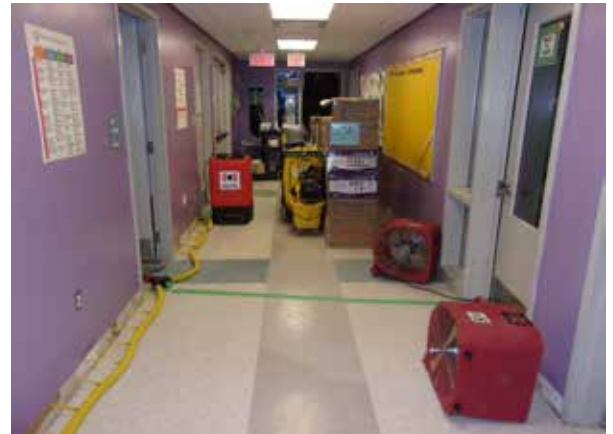
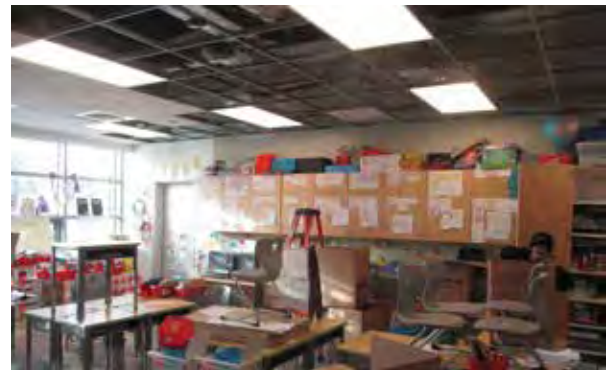
Nathan Hale Arts Magnet School sustained water damage throughout the facility after a component to the HVAC system malfunctioned, allowing cold air to enter from the exterior and freeze a pipe that burst after school hours.

The water caused damage to 13 classrooms, two storage/janitorial rooms, two restrooms, two large hallways, one stairwell and two exit corridors on the first and second floors of the building.

- Two restrooms were affected on tiled walls common to hallways. BELFOR successfully dried these walls and cavities using a cavity drying system, saving the removal/replacement of insulation and tile work.
- BELFOR had vendors/suppliers on site day one to scope materials needed for repairs, ultimately shortening timelines for delivery to site.

- Immediate protection of contents and assets;
- Setting up containment to limit spread of dust and to establish drying chambers;
- Packing of all content within the classrooms, inclusive of storage cabinet, student benches and lockers, and sink locations due to affected walls;
- Thorough inspection and detachment of cabinetry and classroom fixtures as needed;
- Removal of materials as agreed upon by site walk through with representatives from the City of New London and the adjuster. Materials removed included: drywall, insulation, suspended ceiling tiles, vinyl cove base molding, and some cabinetry;
- Setting up of drying equipment and daily monitoring;
- Cleaning and sanitizing of exposed building materials as well as those left in place and dried through to completion;
- Cleaning of furniture and content.

BELFOR brought in a team of 87 project managers, sub contractors, technicians and general laborers. All mitigation and repair work was completed in 10 days.
