**Case Study: MINERAL COUNTY HIGH SCHOOL
Hawthorne, Nevada**

Loss Event: Faulty Roof Drain

Damage: Water Damage

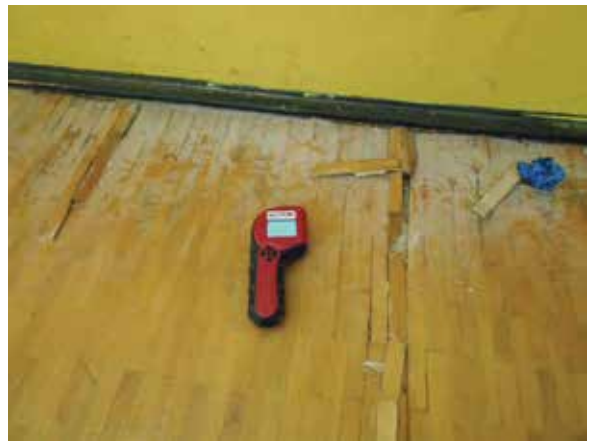
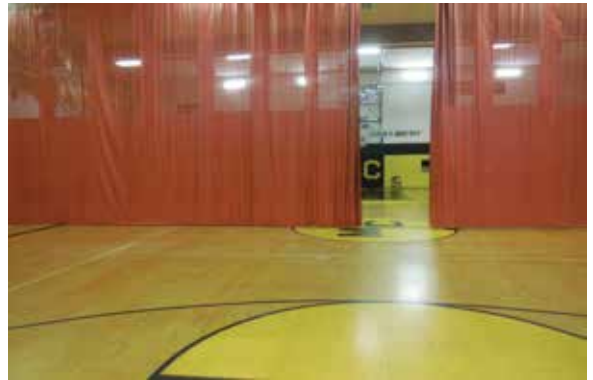
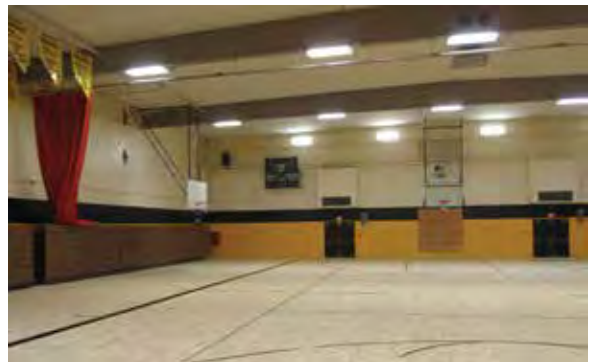
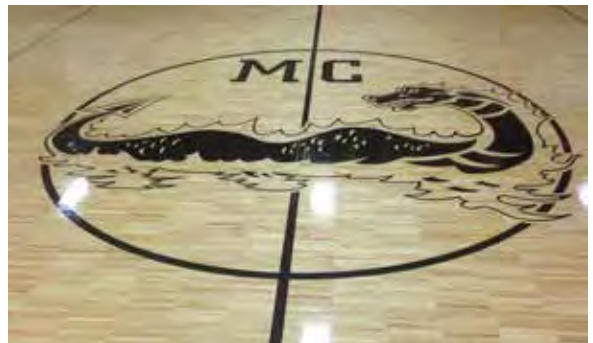
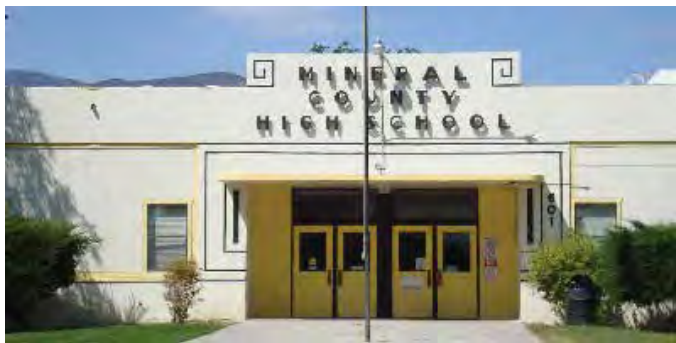
A faulty roof drain caused water to intrude on the Mineral County High School gymnasium floor in Hawthorne, Nevada. The original floor built in 1960 - herring bone wood flooring - began to buckle and an experienced restoration contractor was needed.

After a damage assessment, BELFOR Property Restoration discovered that the hardwood flooring was laid over a polyurethane athletic surface, over slab. In the 1960's, mercury was a common element in the manufacture of polyurethane athletic surfaces, much like lead in paint.

To avoid compromising the substrate containing mercury, only new flooring could be installed over the old flooring. Even if the old flooring could be removed safely, the herring bone wood flooring was no longer in production. BELFOR decided to dry the floor in place using dehumidifiers, standard air movers, and tenting on the impacted flooring.

After the floor was dried, BELFOR installed a new tongue and groove OSB (oriented strand board) overlay with a new hardwood floor over the existing floor. This action saved significant money without sacrificing safety for the school district and insurance PACT/pool.
