PROPERTY RESTORATION

The Royal Mint - Llantrisant, South Wales

Loss Event: Smoke and Fire Damage

CASE STUDY

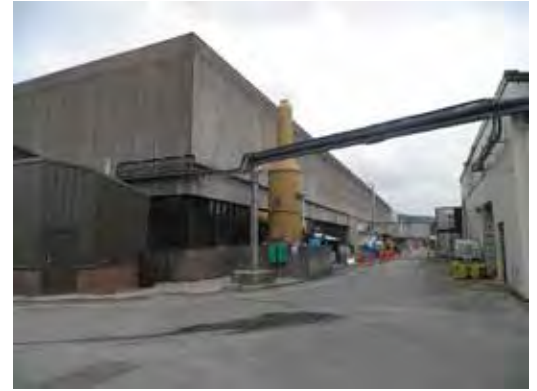
- ▶ The nickel plating plant is a separate building primarily built of concrete and heavily enforced by a steel frame. The fire was unable to penetrate the concrete so the smoke was contained within the structure. Due to the height of the roof (approximately 50 feet) and the need for continued production underneath, the decontamination process was challenging.

- ▶ BELFOR built a "bird cage" scaffolding structure inside the building that contained three different height platforms and consisted of 12,000 boards and 9,000 tons of scaffold poles. Because heat generated by machinery below created unusual conditions, crews were rotated regularly to allow for breaks, but without hindering the schedule.

- ▶ BELFOR used its innovative and unique Soot Removal Film (SRF) product for the decontamination process. Because SRF is "wash-free," odorless, and environmentally friendly with no need for the use of chemicals, production work in the plant was able to continue. BELFOR used more than 18,700 pounds of SRF to decontaminate the 48,000-square-foot plant.

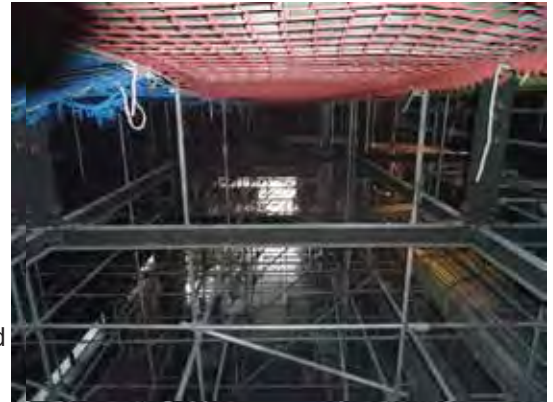
- More Than 18,700 Pounds of Soot Removal Film (SRF)
- More Than 8,800 Labor Hours
